Manhole Inspection Summary

Manhole # S47KK_007MH

Insp Date: **5/2/08 12:38 PM**

Location Address: **Collington Ave**

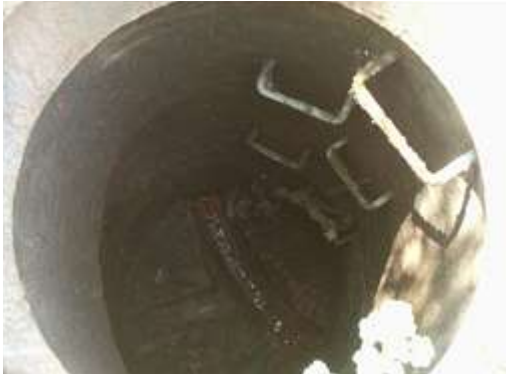
Defect 2

Frame Offset: **2.5** (in.)

☒ **Leaks**

Frame Leaks

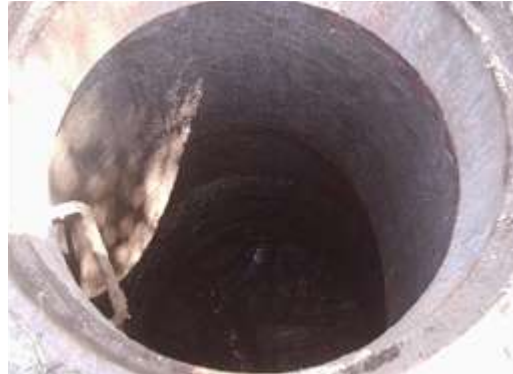
Defect 1

Condition: ☐ Sound ☐ Cracked ☐ Root Intrusion ☐ Loose Brick ☒ **Deteriorated**

Infiltration: ☐ None ☐ Joint ☐ Cracks ☐ Mortar ☐ Roots ☒ **Wall**

Deterioration

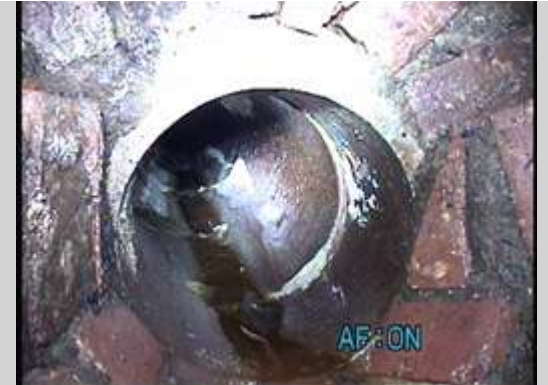
12 O'Clock Outflow

8 in. Circular Gravity Sewer
Pipe Out @ 12 O'Clock

Pipe Height: **8.4** (in.) Rod and Bar (Angled)
Pipe Material: **Clay** ☐ Pipe Lined
Invert Depth: **11.00** (ft.) Flow Characteristics: **Slow**
Deposits: ☒ None ☐ Mud ☐ Gravy ☐ Debris ☐ Grease
Silt Depth: (in.) Deposits Extent:
Infiltration: **None** Pipe Seal Cond: **Sound**

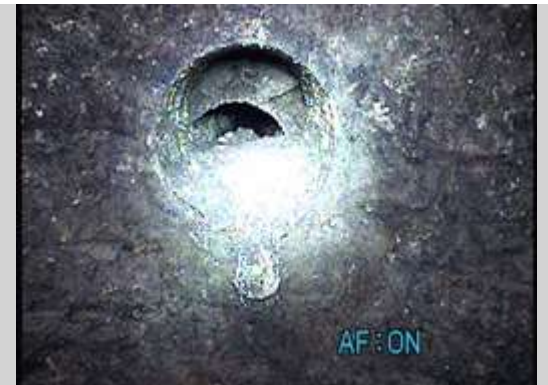
3 O'Clock Inflow

8 in. Circular Gravity Sewer
Pipe In @ 3 O'Clock

Pipe Height: **8.4** (in.) Rod and Bar (Angled)
Pipe Material: **Clay** ☐ Pipe Lined
Invert Depth: **7.80** (ft.) Flow Characteristics: **Slow**
Deposits: ☐ None ☒ **Mud** ☐ Gravy ☐ Debris ☐ Grease
Silt Depth: **3** (in.) Deposits Extent: **Heavy**
Infiltration: **None** Pipe Seal Cond: **Sound**

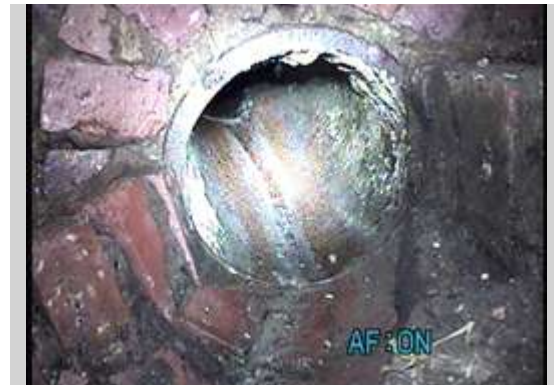
Drop In @ 3 O'Clock

Drop: **Outside** Rod and Bar
Angled: **Yes** Reading: **9.55** (ft.)
Inv Depth: **10.55** (ft.)
Drop Condition: **Open**

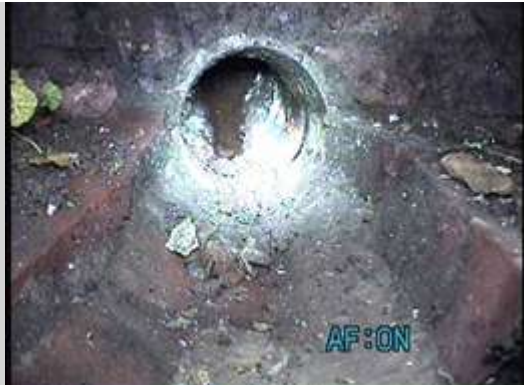
5 O'Clock Inflow

6 in. Circular Gravity Sewer

Pipe In @ 5 O'Clock

Deposits: ☐ None ☐ Mud ☒ **Sludge** ☐ Debris ☐ Grease

Silt Depth: **2** (in.) Deposits Extent: **Medium**

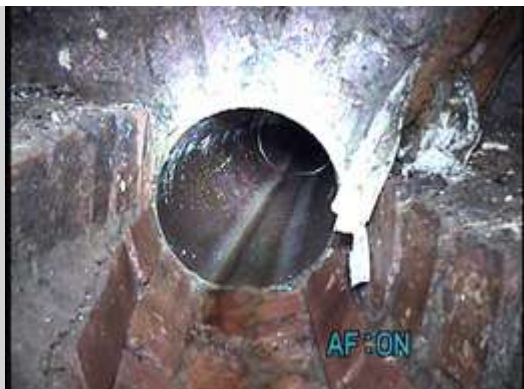
7 O'Clock Inflow

8 in. Circular Gravity Sewer

Pipe In @ 7 O'Clock

Deposits: ☒ **None** ☐ Mud ☐ Sludge ☐ Debris ☐ Grease
